Manhole Inspection Summary

Manhole # S550__035MH

Location Address: **rear 1130 s highland av**

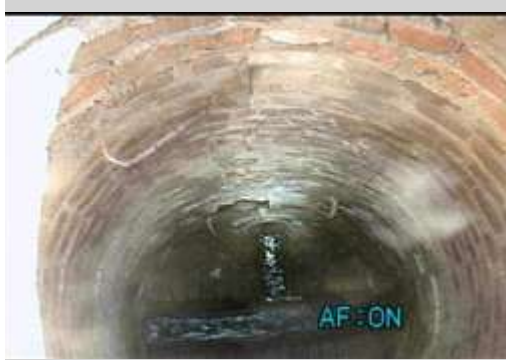
Defect 2

Count: **5** Missing: **5** ☒ Corroded

corr missing steps

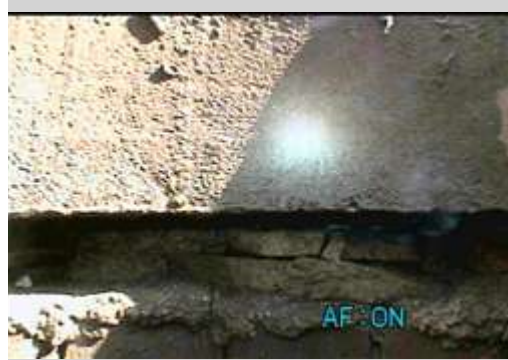
Defect 1

☒ Exists Material: **Brick and Concrete** ☐ Parged Height: **5** (in.)

Condition: ☐ Sound ☐ Cracked ☐ Root Intrusion ☒ Loose Brick ☒ Deteriorated

frame adj

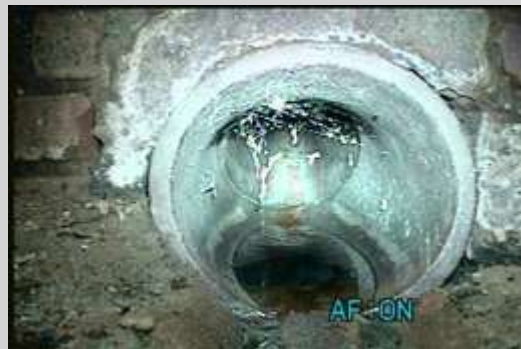
Drop In @ 9 OClock

severely offset pipe joint
